PROGRAM INFORMATION BULLETIN NO. P09-01

SUBJECT: Potential Safety Hazard on J. H. Fletcher & Co. Roof Bolting Machines
with Independent Left and Right Tram Levers

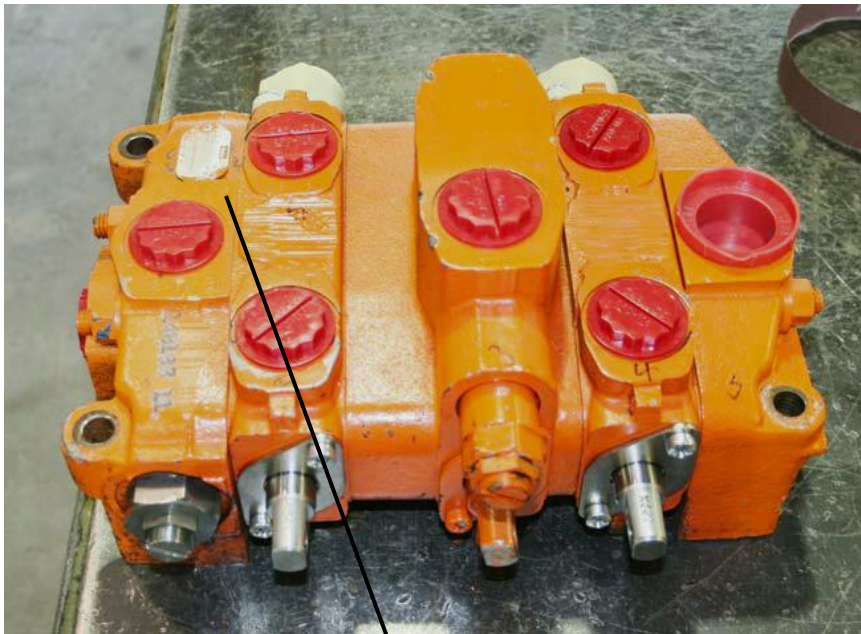
Figure 1 (Tram Control Valve)

- 1: The part number on the tram control valve will be 148133-11 instead of 148133-00. Reference Figure 1 and Figure 2 below.
- 2: The date code in the serial number will be later than the population of suspect tram control valves (H0608-XXXX or later). Reference Figure 1 and Figure 2 below.

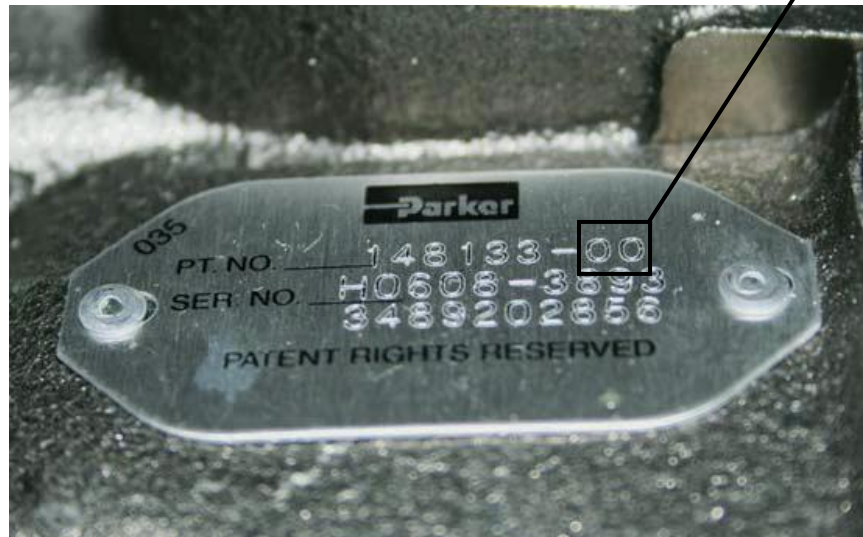
Figure 2 (Identification Tag)

Will be "11"

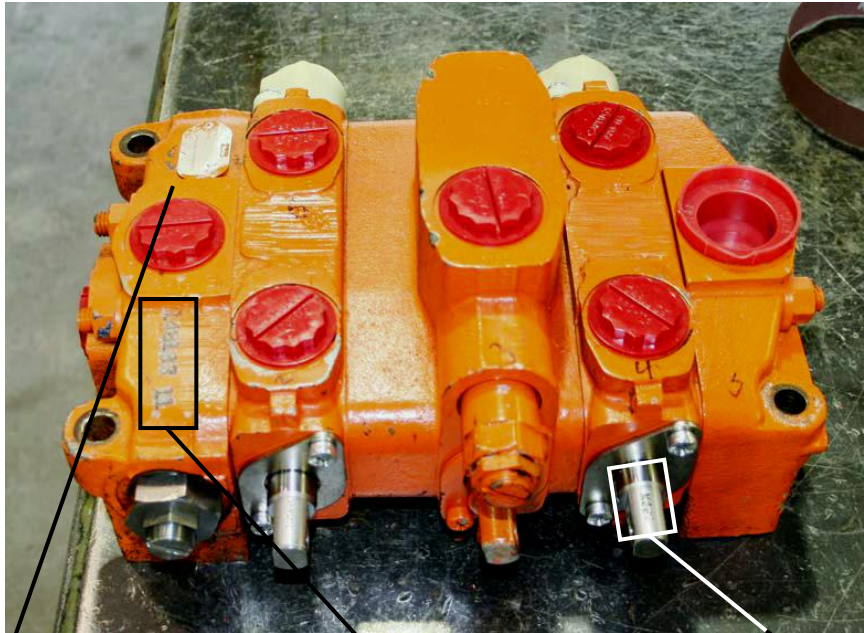
Figure 3
(Tram Control Valve)

- 1: The new part number "148133-11" will be stenciled on the tram control valve body. Reference Figure 3 and Figure 5 below.

- 2: If the original tram control valve tag is present, "11" will be stamped over the "00" at the end of the part number. Reference Figure 3 and Figure 4 below.
- 3: The new spools are stamped with "159X" on the handle end of the spool. Reference Figure 3 and Figure 6 below.
